# FEEDBACK TO THE FIELD (FT2F) #13:

## *Improper Preparation of the Combat Application Tourniquet (CAT) \**

AFMES: COL (Ret) H.T. Harcke, MC, USA\*\*

\* RE-ISSUE: Original Released AFMES/OAFME Jan 2013

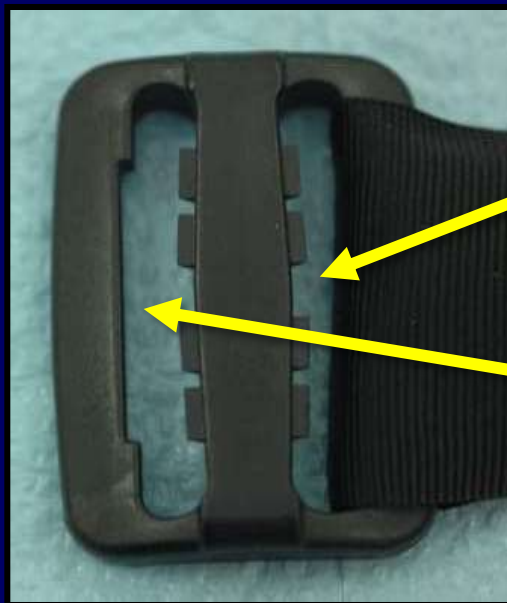
- The CAT's self-adhering band can be routed through the buckle in 3 possible ways...

Inside Slit

Outside Slit

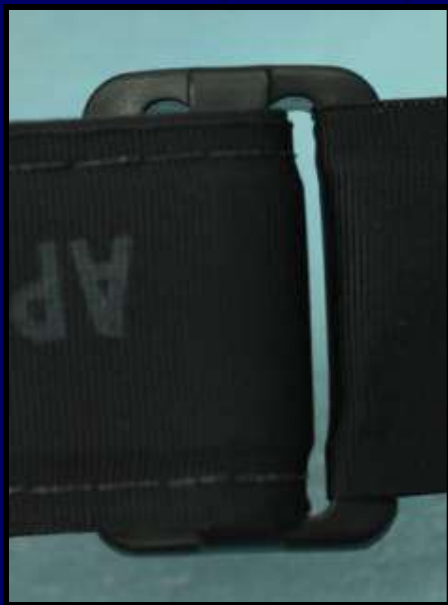
*1 Slit (Inside)*

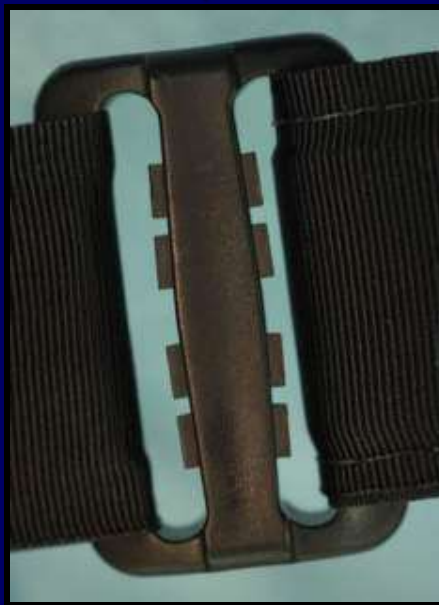
*1 Slit (Outside)*

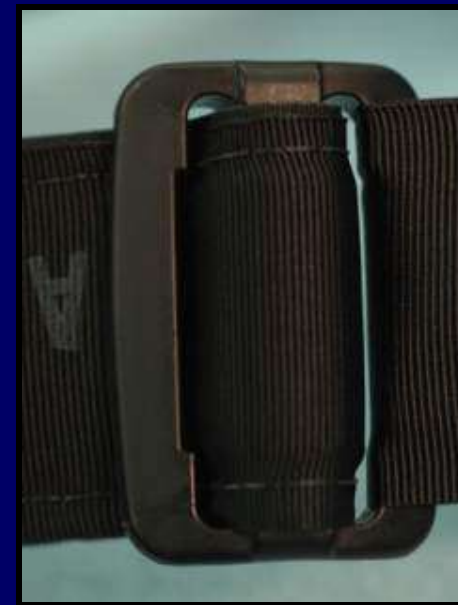
*2 Slits*

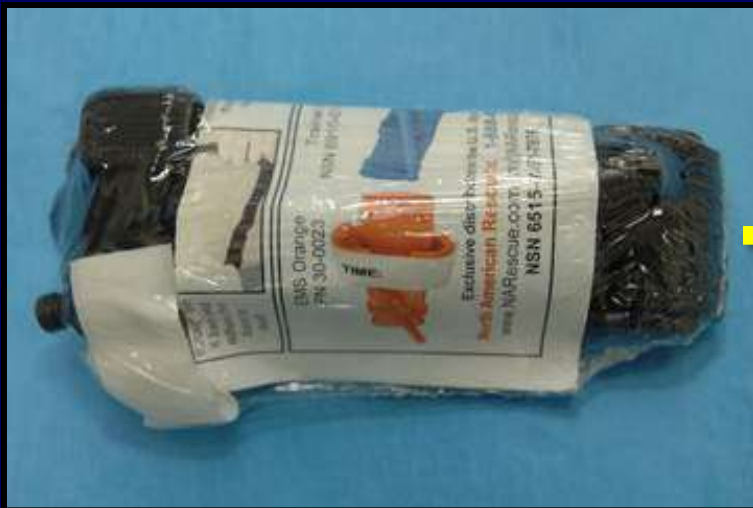
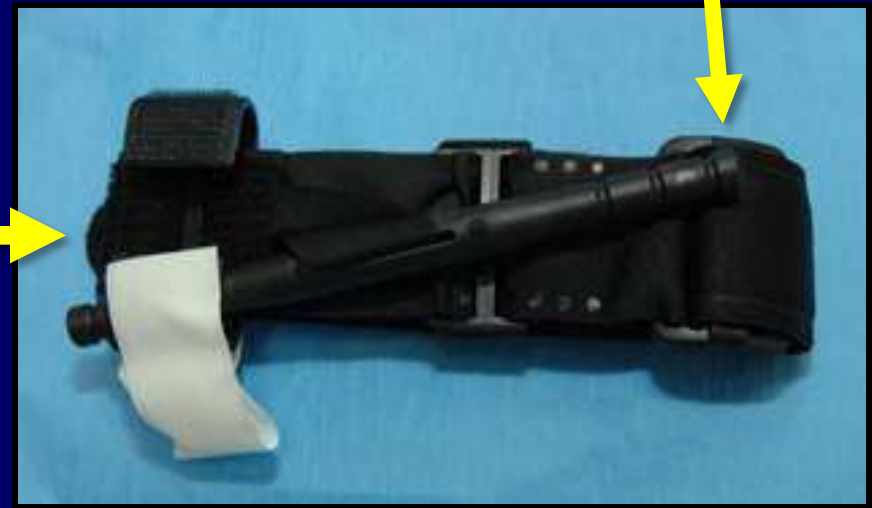
- The manufacturer ships the CAT with the band routed through only one slit (inside)
  - This is the “*Ready to Go*” position...
    - The recommended storage configuration
    - Immediately ready for one-handed applications
    - Band can be quickly routed through the second slit (for two-handed or lower extremity applications)

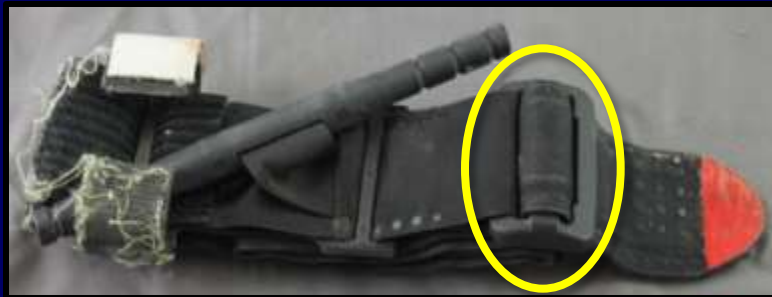
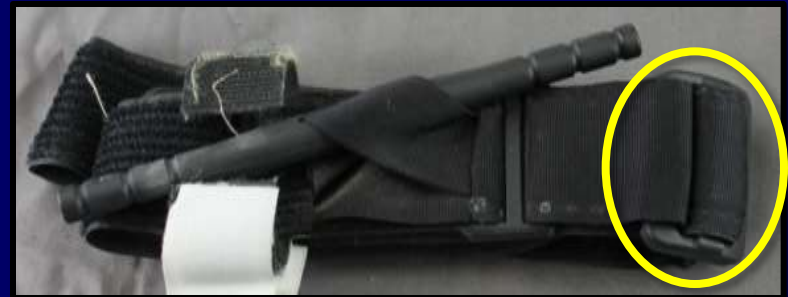
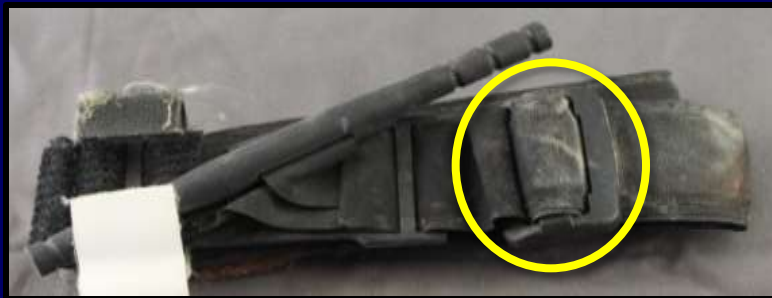
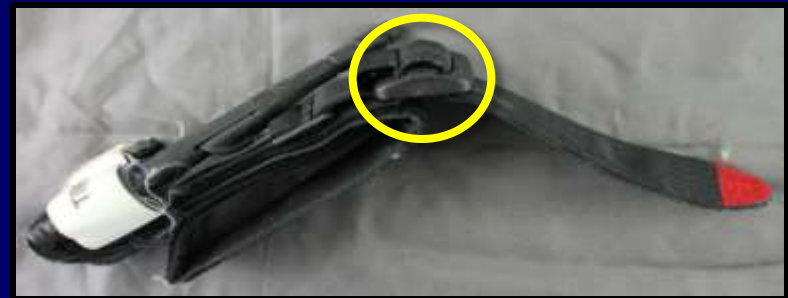
- In Sep 2012, AFMES and DMMPO evaluated 136 CATs that were carried (unused)
  - Eleven (8.1%) had *double routed* bands (i.e., the band was routed through *both* slits)

- Double routing is meant to secure the band *ONCE THE TOURNIQUET IS APPLIED*. If prepared and carried in this configuration, the band must be loosened before the CAT can be used. This takes time and may delay hemorrhage control, especially in one-handed applications.
- The CAT should only be prepared in the “*Ready to Go*” position (i.e., band routed through one slit (inner))

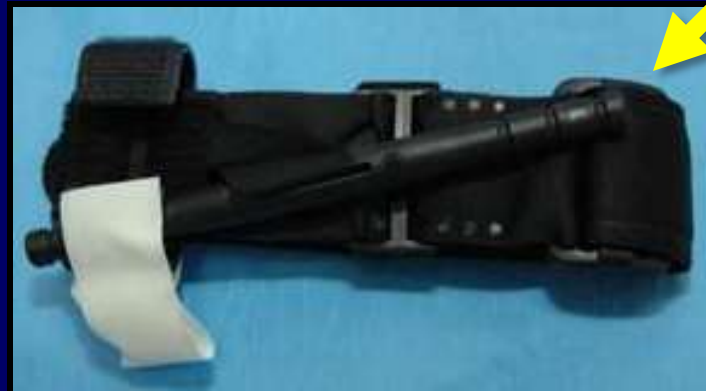
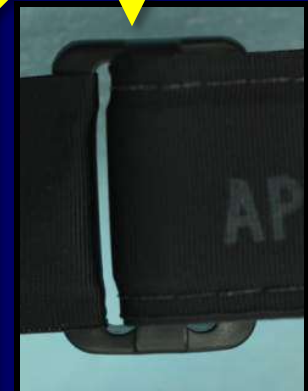
***Ready to Go...  
Is Good to Go!***

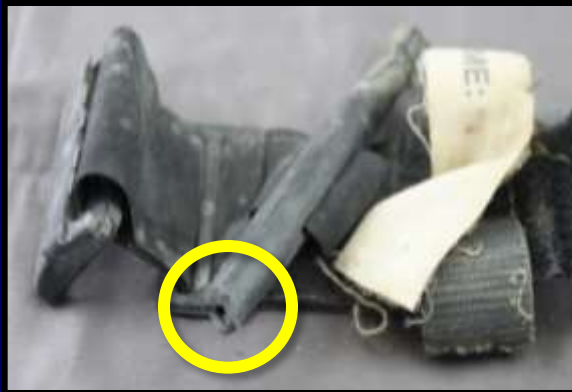
Shortened windlass

- *Windlass length* is designed by the manufacturer
  - If shortened, the tourniquet windlass has:
    - Less torque to control bleeding (i.e., a shorter moment arm)
    - Less security when locked into the windlass clip
- The *red tip* makes the band end quicker & easier to see and locate, especially under poor visual conditions
  - Tip removal or band shortening:
    - May fray the end, create snags, and make it difficult to route the band through the buckle
    - May eliminate or damage spot-welds that are necessary for the CAT to tighten properly; lost welds may render the tourniquet useless (due to separation of the band's internal layers)

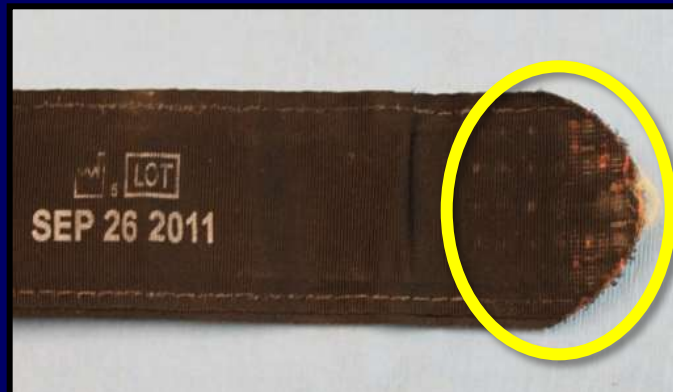
Red tip scraped off

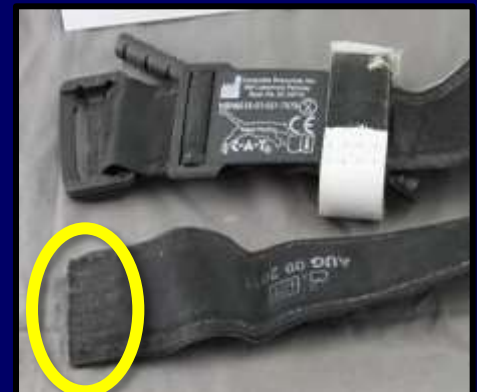
Entire tip cut off

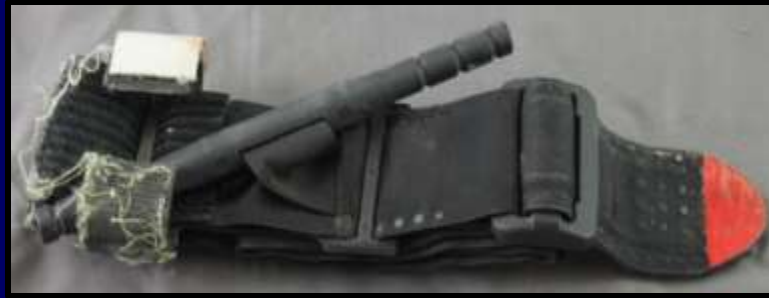
- In this sample, 11 of 136 (8%) carried (unused) CATs were improperly prepared with double slit routing

- Ensure carried CATs are in the “Ready to Go” configuration
- Tourniquets are purposefully-designed and precisely engineered lifesaving devices. They should not be altered for any reason.
- Services should review tourniquet training techniques. Units should inspect devices, detect issues, and reinforce proper tourniquet preparation
- If any characteristic of any tourniquet presents a mission or tactical problem (e.g., windlass length, band length, red tip, etc.), inform the DMMPO POC for action

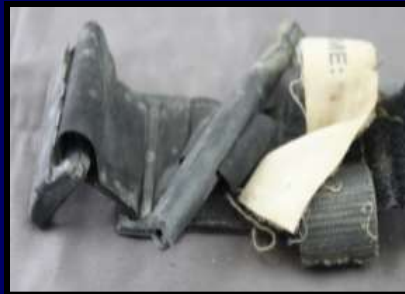
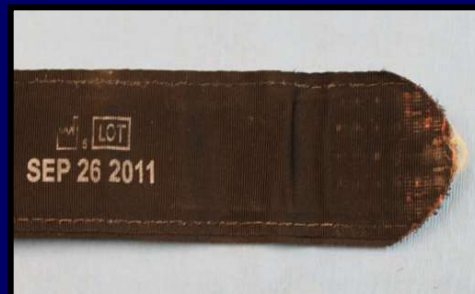
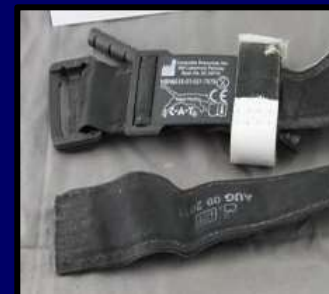
- In addition, 6 of the 136 tourniquets (4%) had been “modified” to shorten the windlass or remove the red tip
